TREES

Report on the short to medium term health and safety of the trees around the high and moderate use areas reference from the GHCW Tree Safety Zones

Prepared for: Gillies Hill Community Woodland (GHCW), Cambusbarron Community Development Trust (CCDT), Trustees and Woodland Management Group, Cambusbarron, Stirling

Date: 21st December 2023

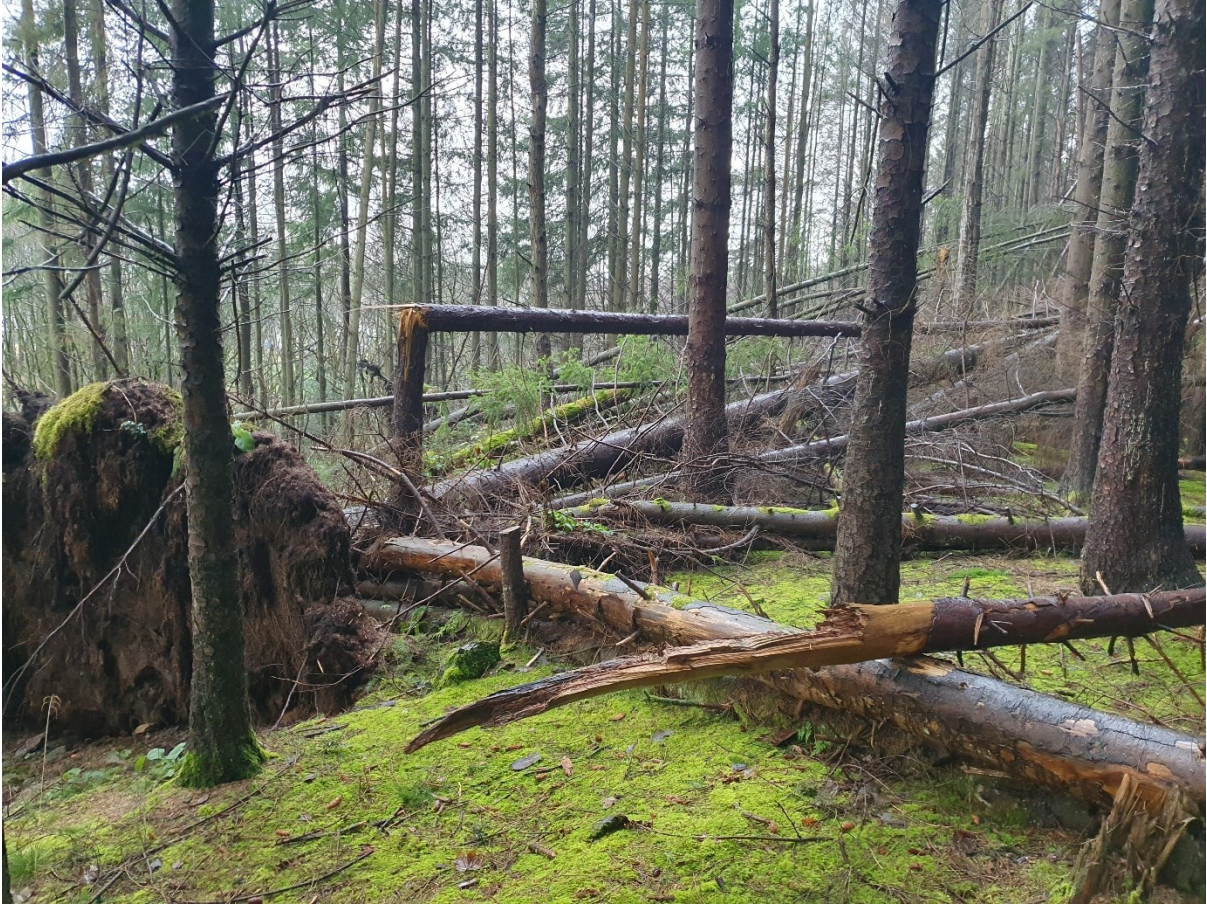
Across the site there are many windblown or part blown trees or groups of trees (See figure 1, Appendix 7.3). This is most obvious in the Dark Woods, which will be dealt with later in this section. Where these windblown or part blown trees could affect the paths, road or access road or those areas deemed as high or moderate use, management recommendation have been given, however further back in the woods they create niche habitat and have therefore not be mentioned. This is important to note as change of use mentioned above will impact this consideration.

Figure 1: Example of Windblown trees on site. This is in Dark Woods and is probably at the more extreme end of the windblown trees

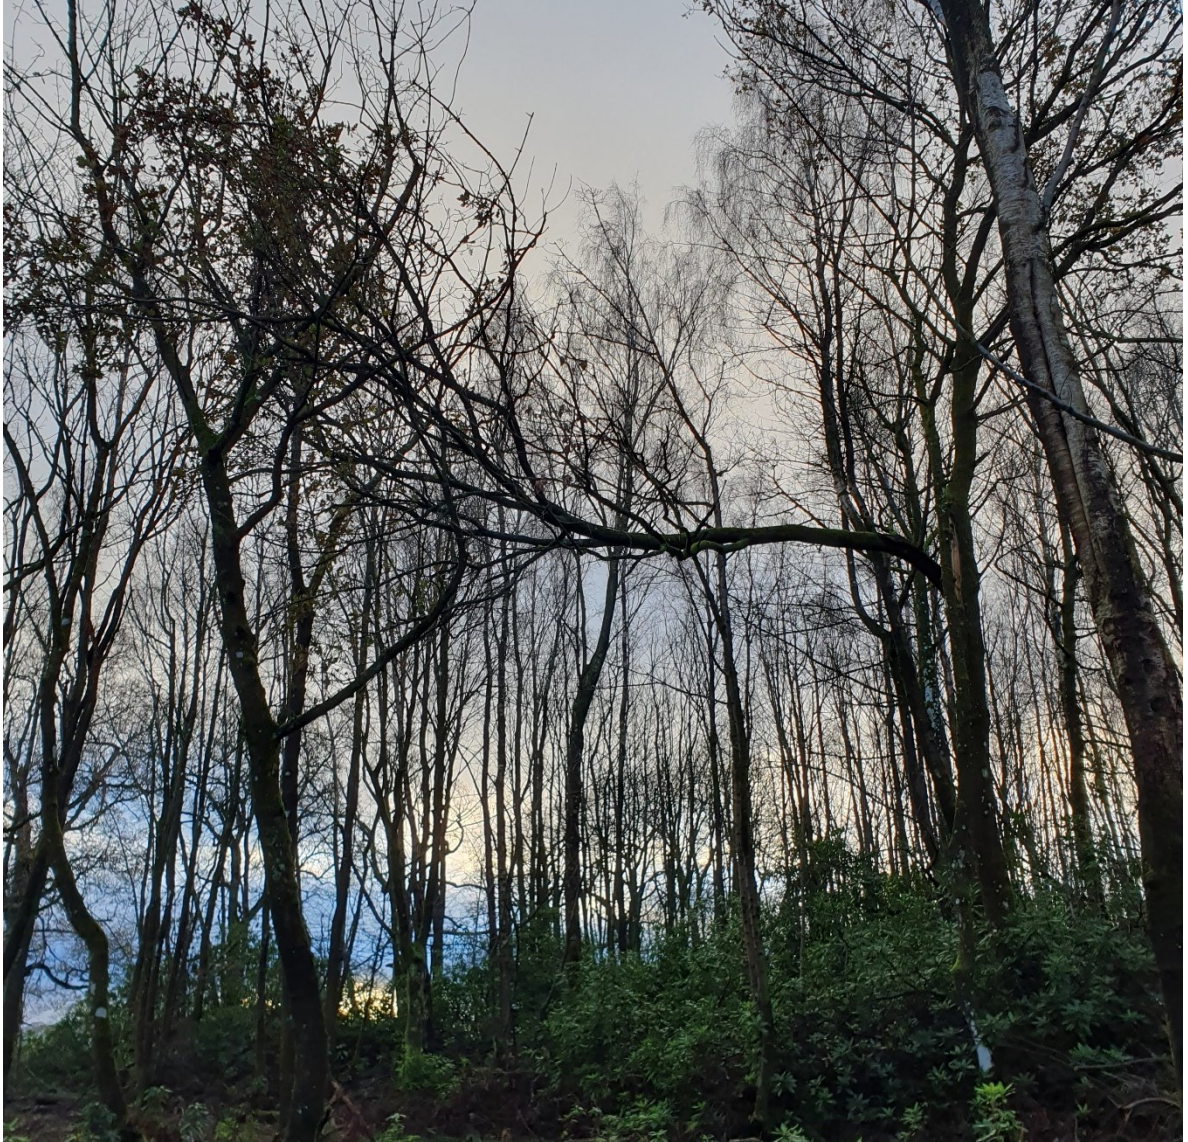
There are a number of trees with failed weak unions, mostly bifurcated cup unions, but some bifurcated wide inclusions. Some were also trifurcated or had more stems and some of which had already failed (See figure 2, Appendix 7.3). When there were weak unions they have been noted and any mitigating factors such as types of natural bracing, for example fused stems and fused branches have been considered.

Figure 2: Failed union on Oak (4094). The failed union is towards the path and held up only by an adjacent tree near the path edge.

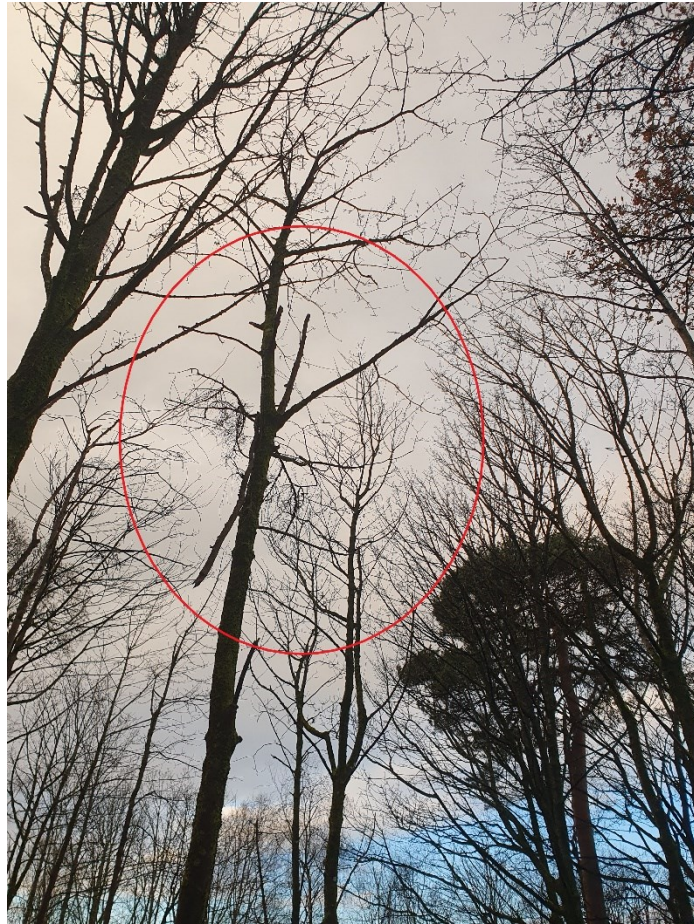
With areas of Rhododendron and trees being cleared this is having an impact on the adjacent trees. Some have long lateral branches or slimmer stems that are cracking and failing or partially failing. It is also the case that tree work has left dangerous hanging branches and damaged trees (See figure 3, Appendix 7.3).

Figure 3: Large hanging branch from Larch felling, circled in red. This example in a Sycamore over the footpath that accesses the school.

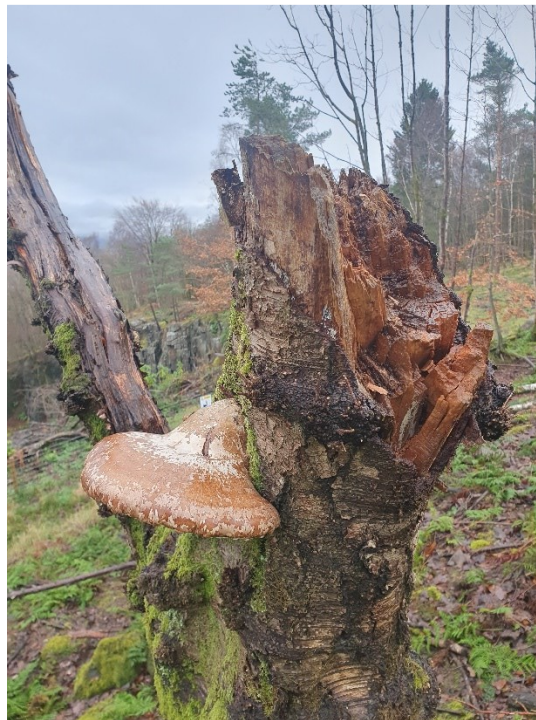
Figure 4: Example of failure that can occur with Birch Polypore. This tree has already failed and poses no risk, but the brown rot and type of brittle degradation can be seen in the image.

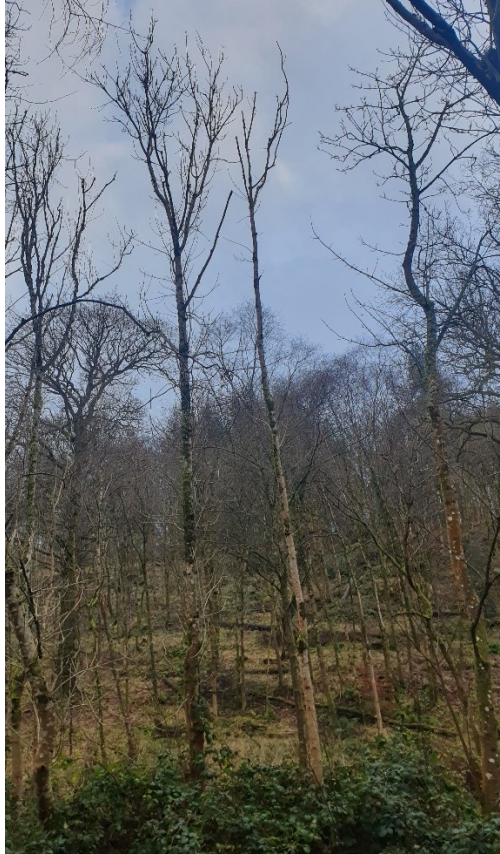
Figure 5: Examples of class 4 Ash trees, with advanced Ash Dieback, next to Cambusbarron Primary School path.

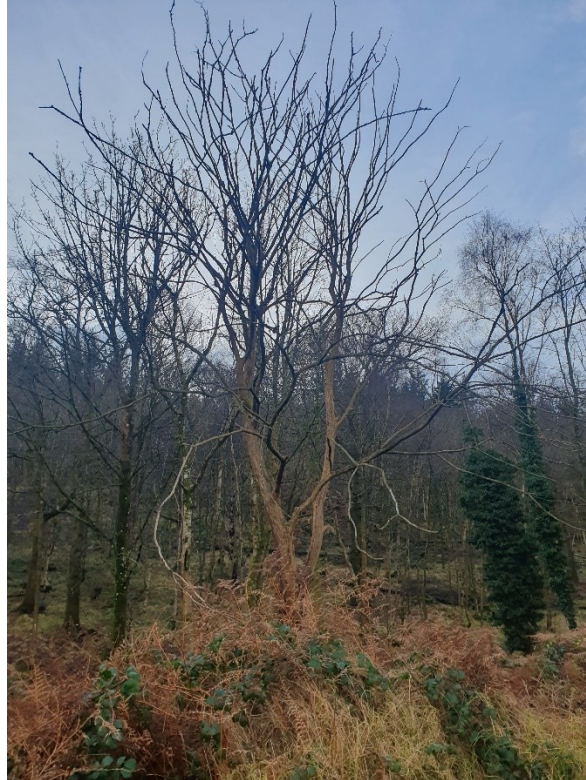
Figure 6: Examples of Elm that has recently died of Dutch Elms Disease, next to Cambusbarron Primary School path.

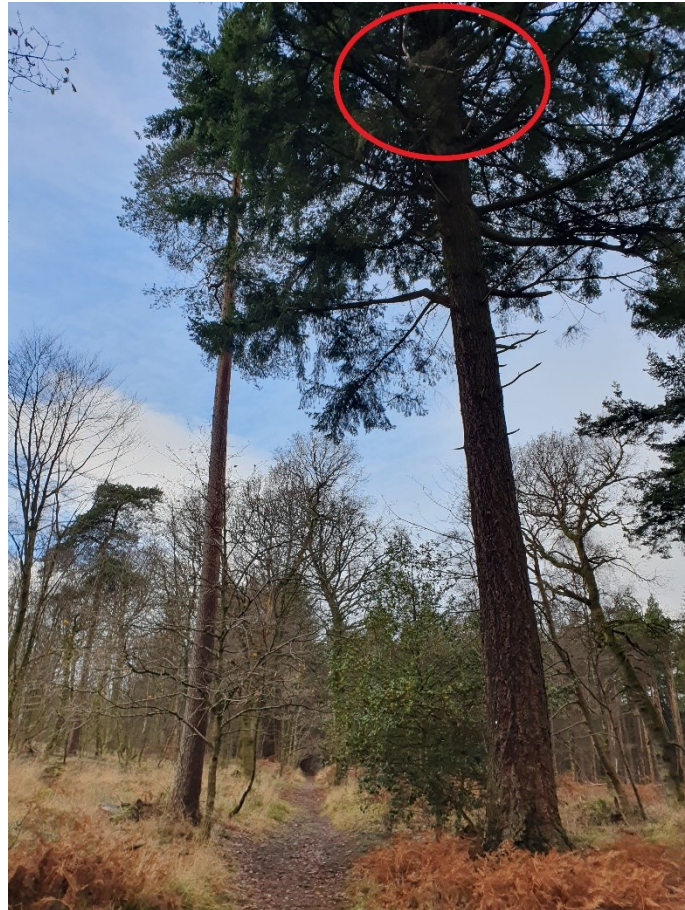
Figure 7: One of the hanging branches and partially failed branches in a Douglas Fir (4177) over a path.

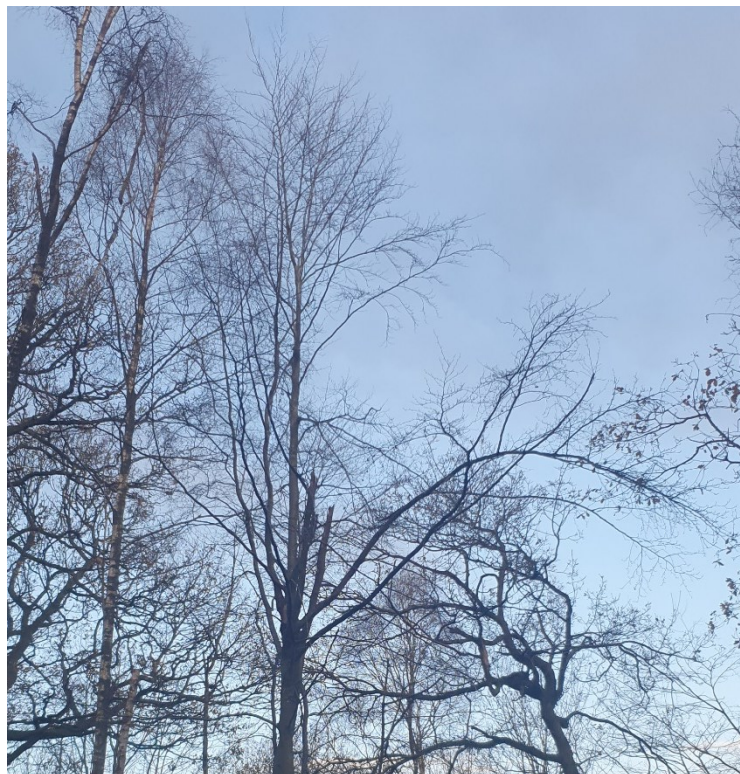
Other trees on site that are showing common failures for different reasons are Sycamore (*Acer pseudoplatanus*) and Beech (*Fagus sylvatica*) (See figure 8, Appendix 7.3). This was sometimes for biomechanical reasons mentioned above, but commonly it is because of the impact of Grey Squirrels (*Sciurus carolinensis*). The repeated damage caused to the upper sides of many branches and sections of stem especially around unions does not allow the trees to recover, in some cases resulting in failures.

Figure 8: Gap in crown of Beech (4008) with several failed stems and branches as a result of squirrel damage

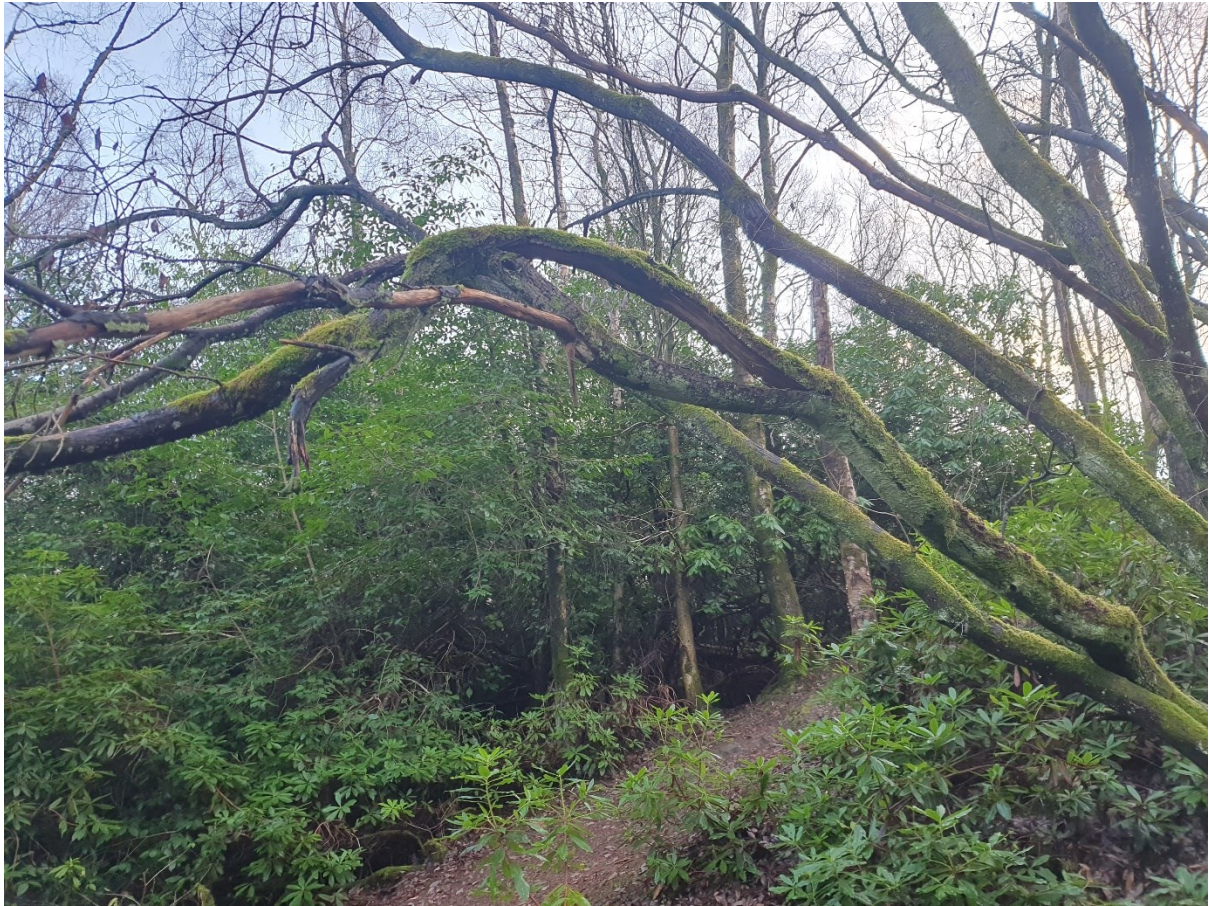
due to the brittle nature of the wood you are also seeing stem and branch fractures (See figure 9, Appendix 7.3).

Figure 9: Willow (4119) with fractured branch over one of the access paths to the Castle.

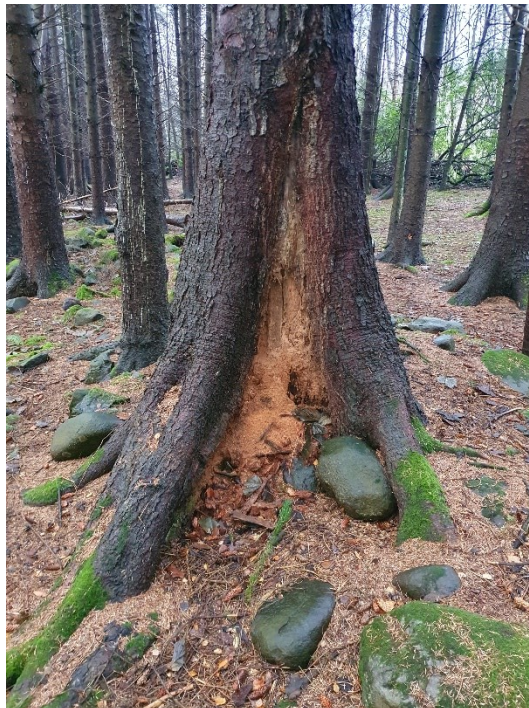
The Dark Woods were discussed on the earlier site visit, but there is a large area of windblown trees within this area as well as the largest frequency of fire damaged stems, which are beginning to develop decay cavities (See figure 10, Appendix 7.3). Fortunately most of the windblown areas do not currently affect the high or moderate use areas. However where individual trees do affect these areas they have been highlighted. It is worth mentioning two other points about the Dark Woods. Firstly the likelihood of windblown trees in an even aged commercial conifer plantation of this maturity will only increase. Secondly clear felling and restocking, if that is decided on, will have an impact in the short term on the adjacent trees. This will result in an increases in branch and stem failures in the exposed trees once this area is managed. This should be done with the support of a professional forester.

Figure 10: Decay at the base of a Sitka Spruce in the Dark Wood as a direct result of fire damage.

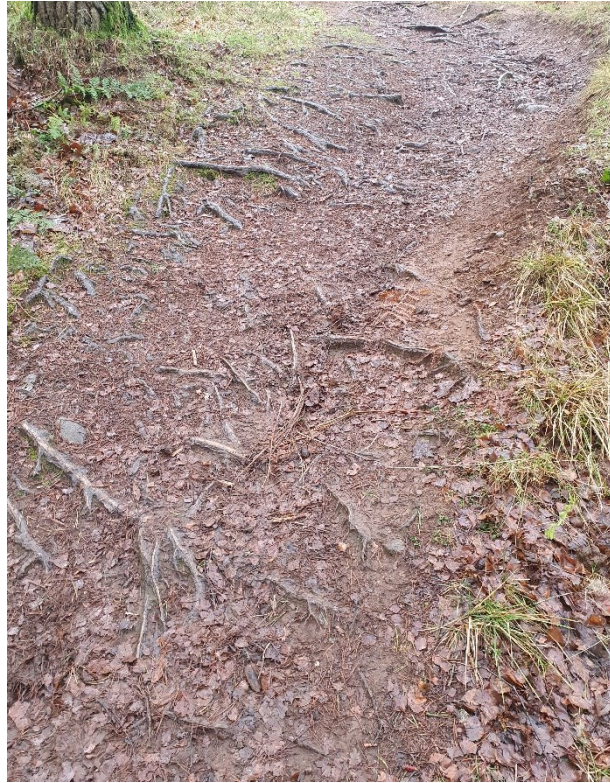
The footpaths, mountain bike tracks and access tracks show the popularity of the site. However most of the footpaths that still have trees nearby are showing signs of root damage (See figure 11, Appendix 7.3). Whether that is severed roots (See figure 12, Appendix 7.3) or damage to roots. This coupled with the compaction caused by the use of the site should be considered as the sites usage continues to evolve.

Figure 11: Path erosion and resulting root damage affecting the condition of adjacent trees, although difficult to avoid, path design could mitigate this to an extent.

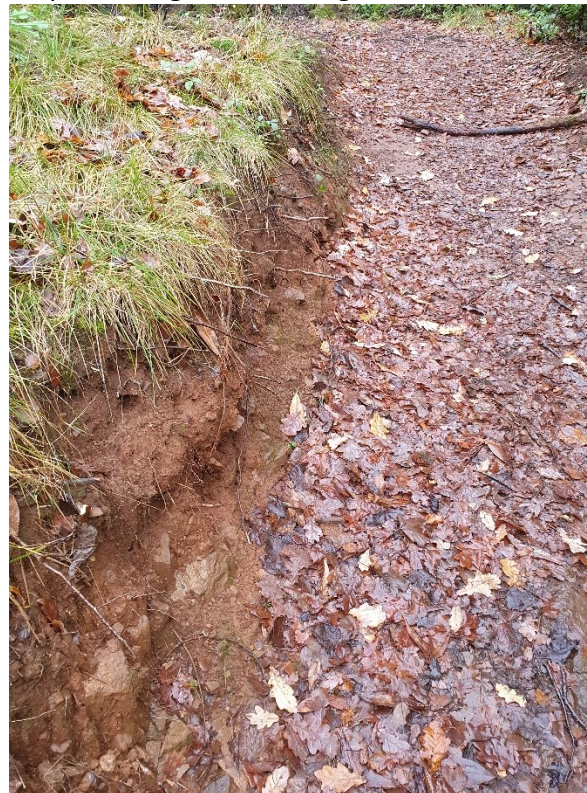
Figure 12: Image of root damage due to path construction.
