TREES

Report on the short to medium term health and safety of the trees around the high and moderate use areas reference from the GHCW Tree Safety Zones

Prepared for: Gillies Hill Community Woodland (GHCW), Cambusbarron Community Development Trust (CCDT), Trustees and Woodland Management Group, Cambusbarron, Stirling

Date: 21st December 2023

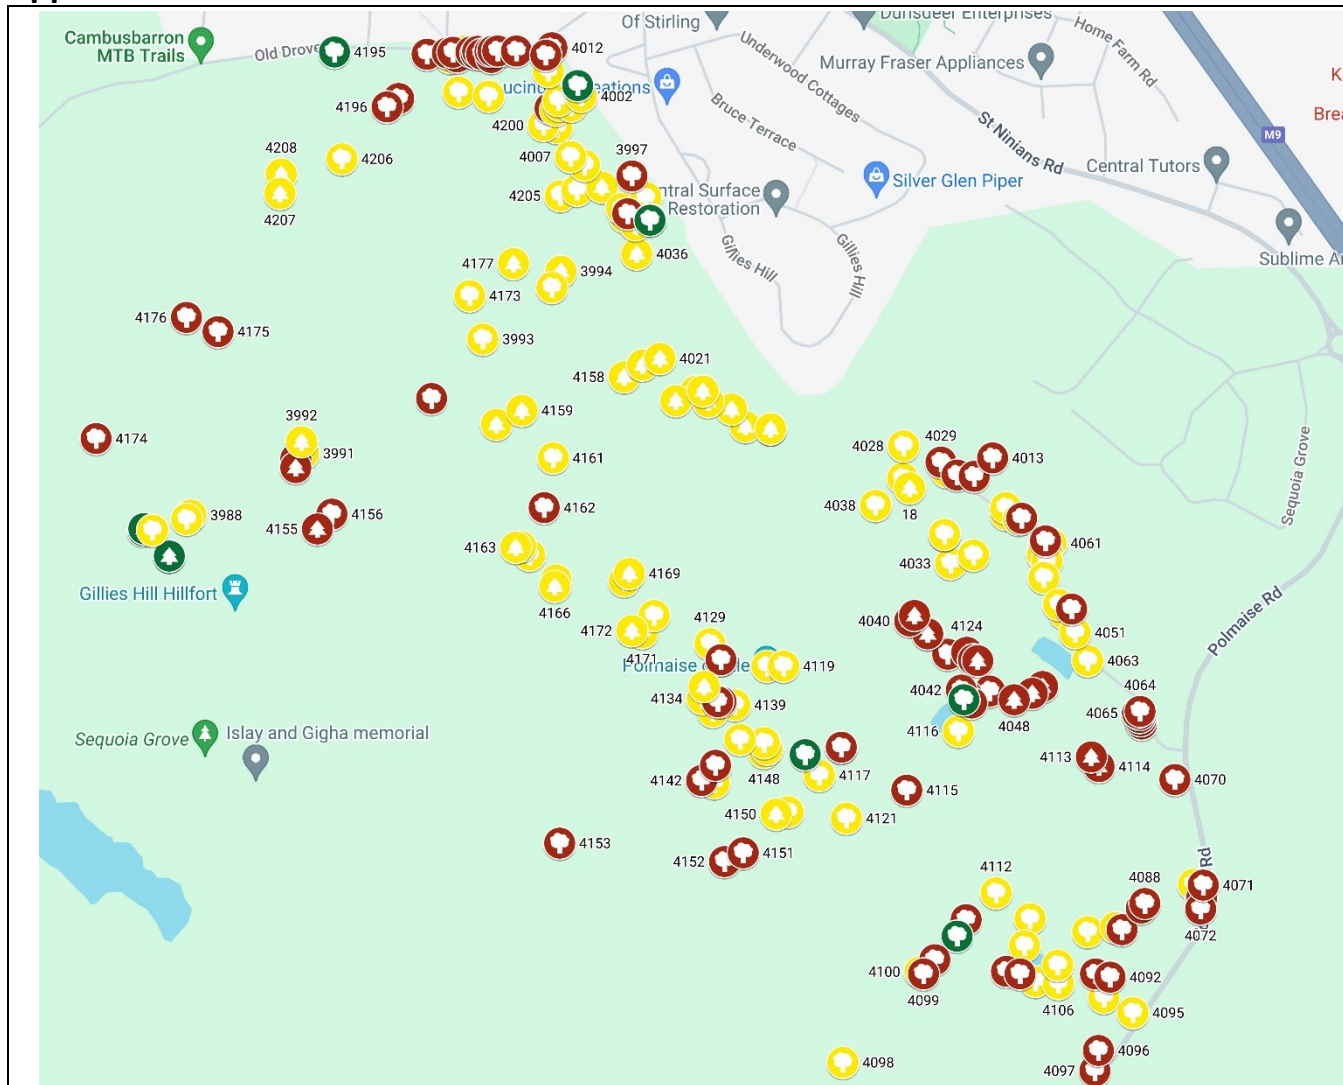
Appendix 7.4 Site Plan

Site Plan showing the trees recorded in the negative tree survey for Gillies Hill Community Woodland

Numbers indicate the tag number
